**DEPARTMENT OF ENVIRONMENTAL MANAGEMENT
INDIANAPOLIS**

OFFICE MEMORANDUM

SUBJECT: Site Visit Summary for Ecological Systems Inc. conducted on October 19, 2010, located at 4910 West 86th Street, Indianapolis, Marion County, Indiana.

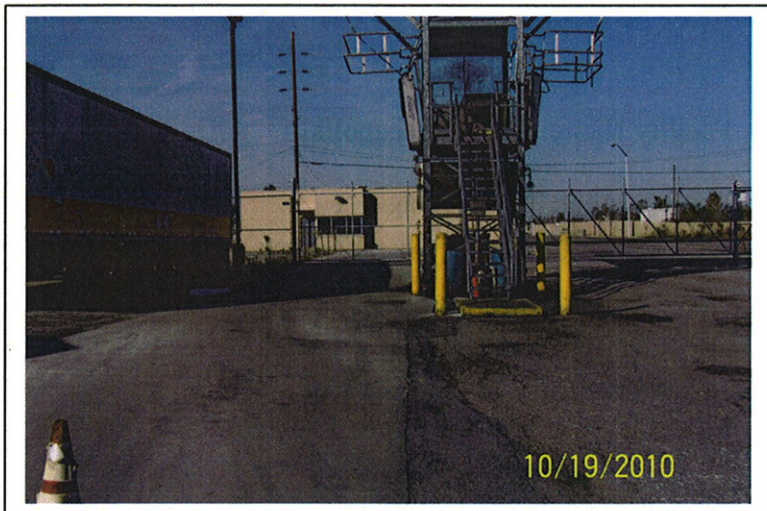
Location & Description: View of manhole identified as SS3. Receives runoff from truck sampler.

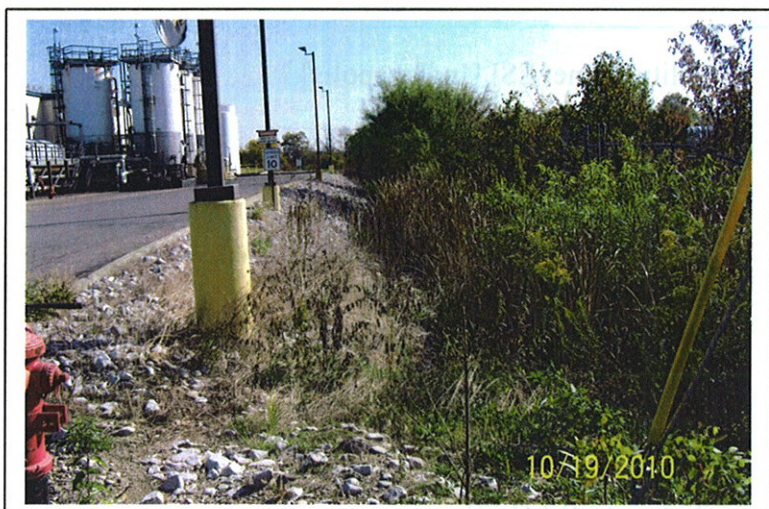
Location & Description: View of PDP2 and SS7 (in distance). The truck scale perimeter holds a lot of water, possible seepage thru curb, unsure of integrity of structural containment, and high potential for O&G. Water depth was measured with a drum sampler at 3'8" and there is a potential for sludge build-up at bottom.

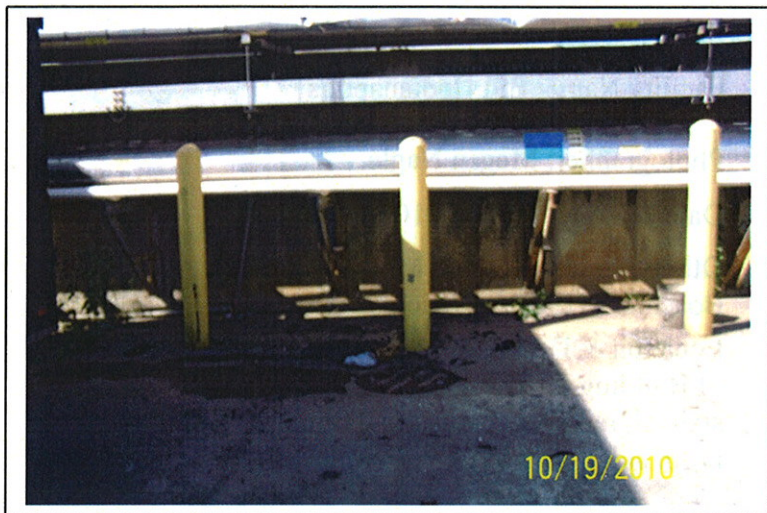
Location & Description: View of SS12. Receives roof drain runoff from Building 1 (northwest side). Believed to drain to Oil Pit.

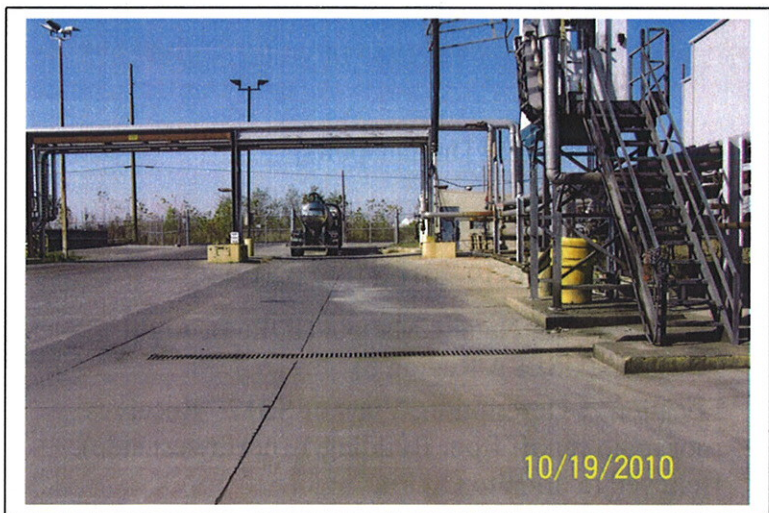
Location & Description: View of SS15, receives runoff from immediate parking lot area. High potential for TSS and O&G from stained area.

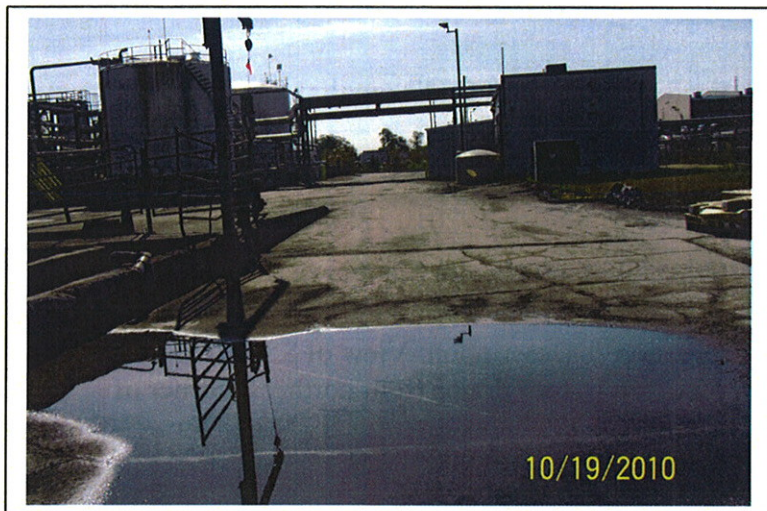
Location & Description: breach in berm, located near oil sludge storage.

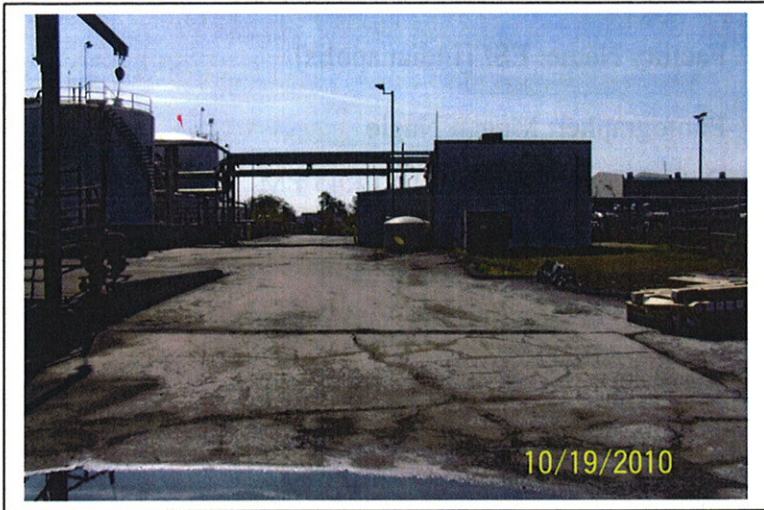
Location & Description: Pooling water near the solidification pits.

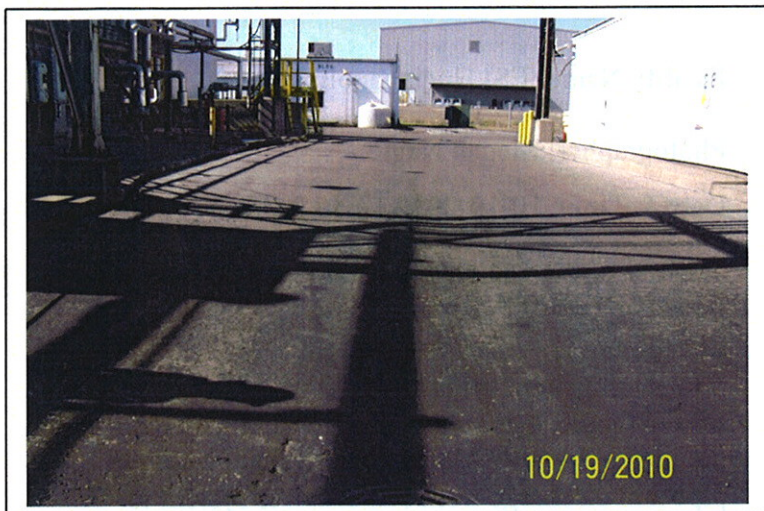
Location & Description: View of SS23, heavy staining surrounding the drain with a high potential for O&G. Pumping of the drain was initiated on 10/15/2010, still pumping at the time of the site visit on 10/19/2010.

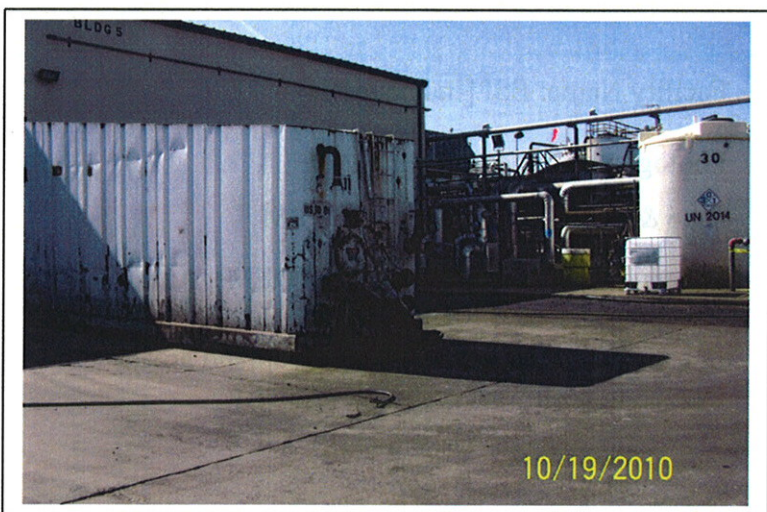
Location & Description: View of SS24. Surrounding area is heavily stained, high potential for O&G, receives runoff from Building 5. This is the drain which EPA proposes to attach a culvert pipe and discharge from storm sewer system to tributary to Oil Creek.

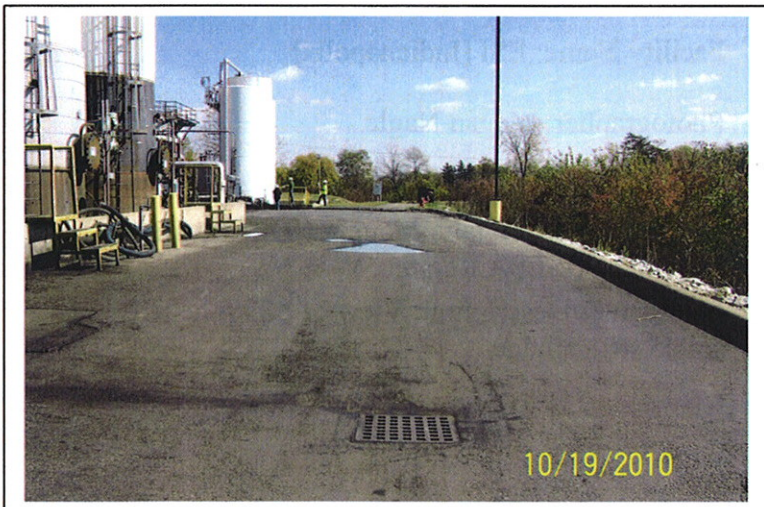
Location & Description: View of SS28, heavily stained. SS28 receives runoff from area contaminated by "Fry Basket".

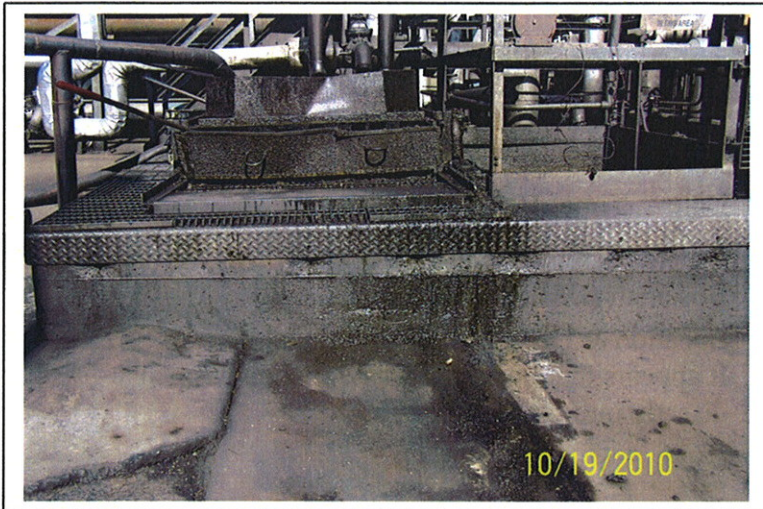
Location & Description: View of SS28, photograph taken facing East.
